Water Quality and Vegetation Study
Senior Capstone ENVS 460: Fall 2019

Ayden Allen, Cameron Dole, William McCuen, Garrett Scales, Benjamin Whiting, Thomas Wohl

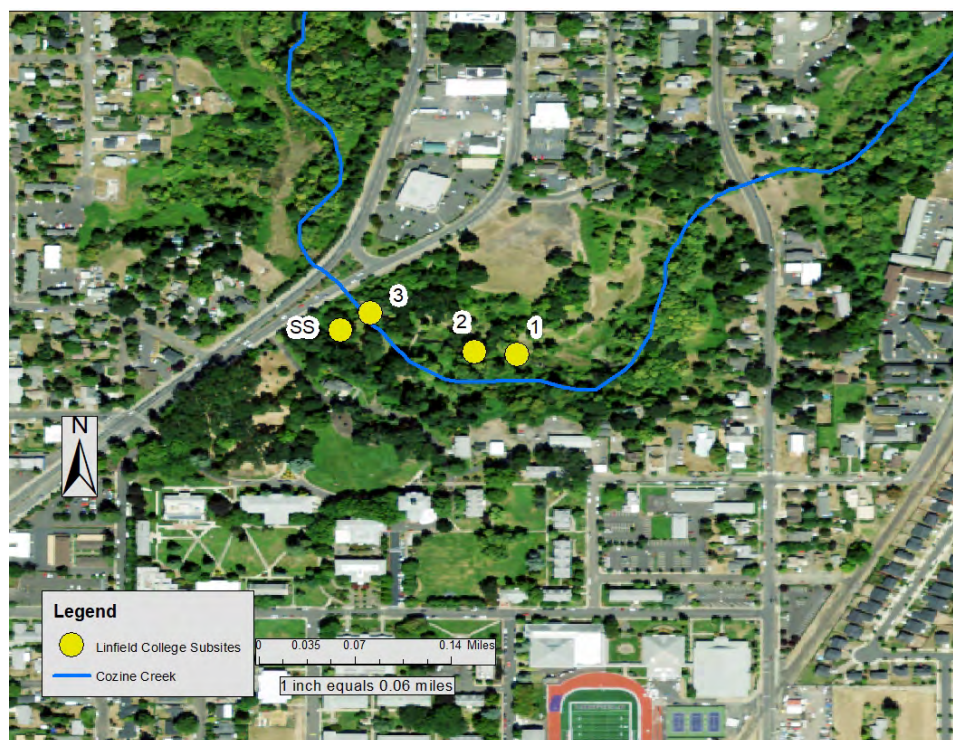
Figure 3. Map detailing location of the four Linfield College subsites on Cozine Creek (Map created by William McCuen using ArcGIS software).

The first location we sampled was where Cozine Creek runs through Linfield College's campus (Figure 3). The site is located at the northern side of the campus and is the most downstream location of the three areas we tested. This site originally was established in spring 2011 and has been tested annually. This location originally was selected because it is located on college property and represented an urban setting for the ENVS 360 spring 2011 study examining the impact of urbanization on water quality. Three subsites were randomly (Colahan et al., 2011). We also sampled a fourth subsite (the side stream) that was added in fall 2017. The side stream is believed to be water from of overflow storm drains and lawn runoff potentially from across Baker Street; it was tested to compare its water quality to that in the main channel and to determine if it could be a source of nutrients (Schmidt et al., 2018). We tested the water at this site on two dates due to the omission of BOD measurements for the first date; we tested on September 4 and September 25, 2019.

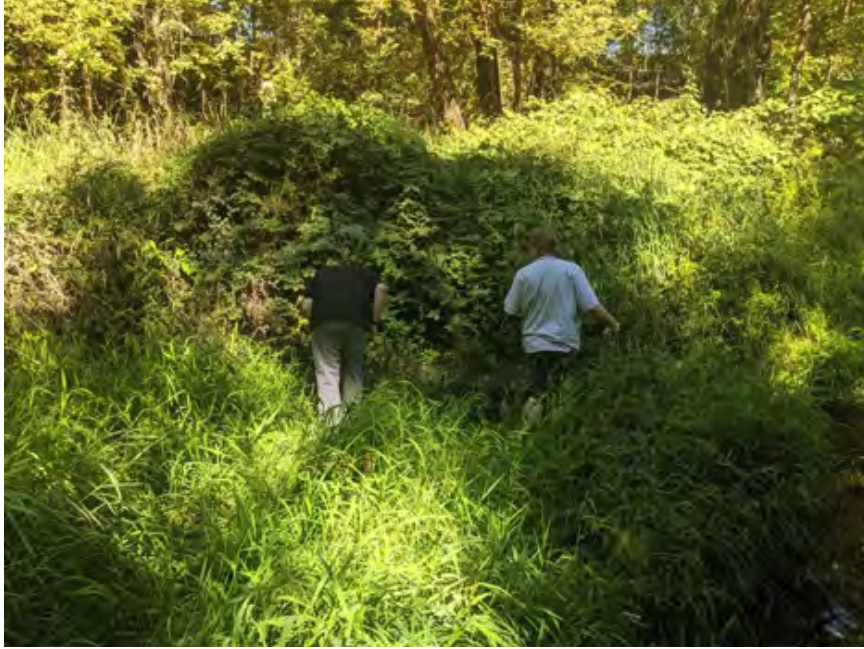
Subsite 3 was the most upstream of the subsites at this location. Just upstream from where we sampled was a culvert that runs under Baker Street. This concrete culvert has two sections, each about six feet tall and eight feet wide. The site itself consisted of a small stream about 3 feet wide with a shallow pebble riverbed that dumped into a larger pool about 11 feet across. A few trees provided some shade. Oregon ash and willow trees (*Salix* sp.) lined the bank and a large dead cottonwood tree was on the other side. Ninebark, reed canary grass, Himalayan blackberry, tansy ragwort, poison hemlock (*Conium maculatum*), trailing blackberry, and clover (*Trifolium* sp.) were on the bank (Figure 4). A small side stream flowed into the main channel here; this is the side stream we tested and will discuss next. We also heard and saw many bushtit birds at this location.

Figure 4. Cozine Creek and streamside vegetation at Linfield College Subsite 3 (Photo taken by Benjamin Whiting).

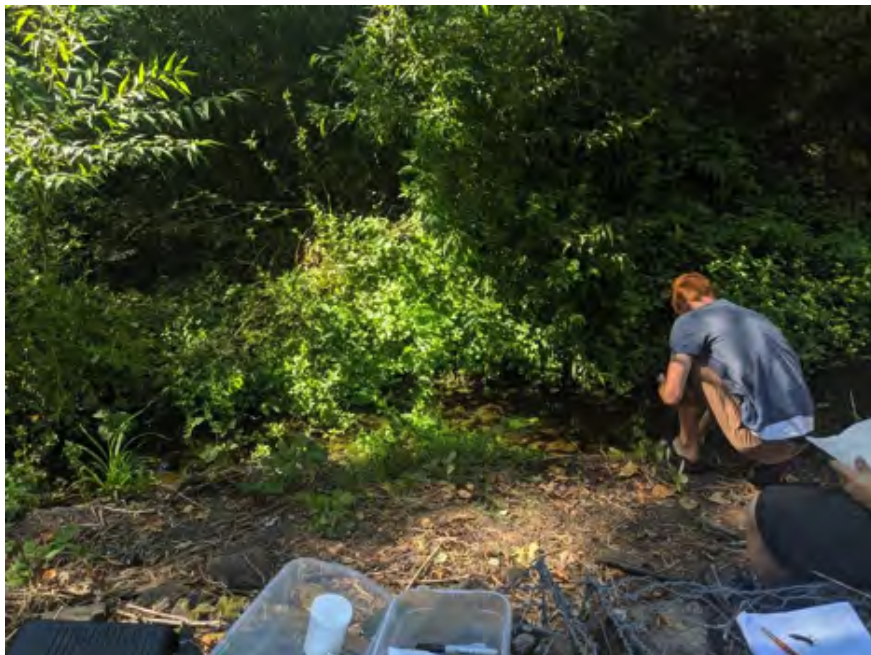
This stream was narrow, with a width of about three to four feet. The bottom of the slow-moving stream was muddy with a thick layer of algae. The creek had woody debris on the bottom. Neither side of the stream had any significant slope (Figure 5). The side stream is sectioned off from the area where the main channel of Cozine Creek is by a two-foot-tall rock retaining wall covered with wire. Trees in the area included Oregon white oak, Oregon ash, Douglas-fir, cascara (*Rhamnus purshiana*), vine maple (*Acer circinatum*), and an ornamental birch (*Betula sp.*). Bittersweet nightshade (*Solanum dulcamara*), sword fern (*Polystichum munitum*), and Himalayan blackberry also were observed. It is important to note that the side stream is very close to Baker Street, which is a heavily trafficked road. The side stream is probably water from the overflow of storm drains and runoff from lawns near the 7/11 convenience store just off campus across Baker Street (Personal communication, Javier Mendoza, November 25th, 2019).

Figure 5. The side stream subsite we tested at Linfield College (Photo taken by Benjamin Whiting).

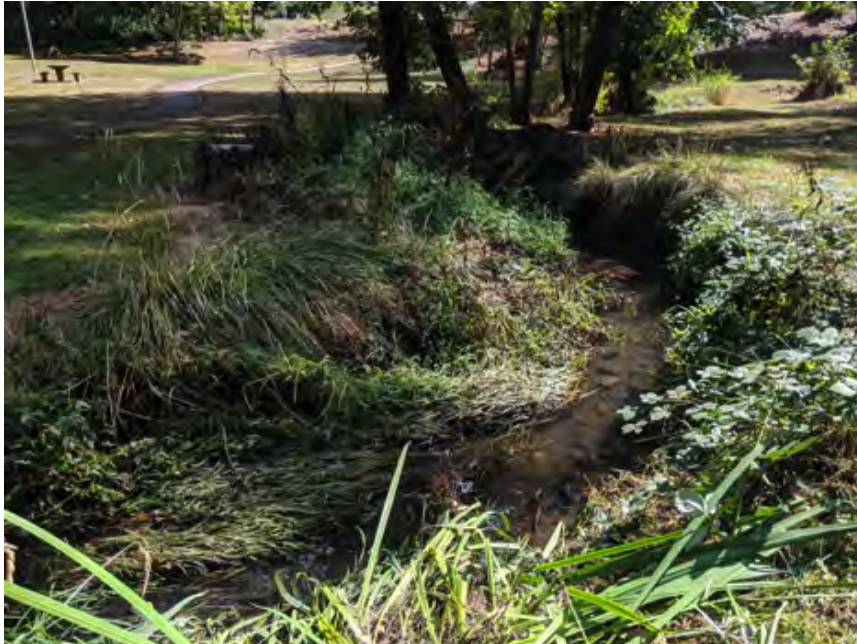
The creek at Library Subsite One was about three feet wide and had a muddy bottom with scattered pebbles and stones. It had very low flow. This subsite was the most downstream site at this location and was slightly upstream of 2nd Street in McMinnville. Both sides of the stream had steep slopes (Figure 7). The area had scattered Oregon ash, Oregon white oak, and willow. Other plant species included Himalayan blackberry, horsetail (*Equisetum arvense*), bittersweet nightshade, yellow-flag iris (*Iris pseudacorus*), dock (*Rumex occidentalis*), and reed canary grass. We also noticed waterstriders on the surface, dragonflies in the air, and small fish and crayfish in the creek.

Figure 7. Photo of Cozine Creek where it flows through our Library Subsite 1 (Photo taken by Benjamin Whiting).

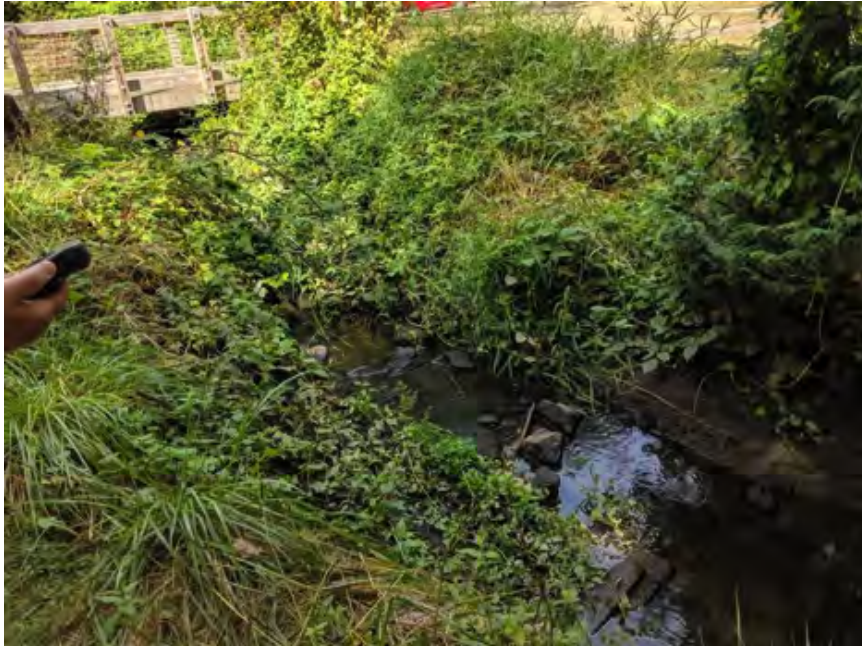
At Library Subsite 2 the creek was about three feet wide and had a muddy, silty bottom with a few scattered rocks. The flow here was very low, possibly due to the large amount of vegetation in the creek. This subsite is just downstream of a small footbridge over the creek (Figure 8). There was some canopy cover from mostly ornamental trees including Norway maple (*Acer platanoides*), quaking aspen (*Populus tremuloides*) and arborvitae (*Thuja occidentalis*). Other plants included Himalayan blackberry, dock, English ivy, and non-native hawthorne (*Crataegus monogyra*) We also observed water striders and a clam shell in the creek.

Figure 8. Subsite 2 showing vegetation and the footbridge at the Library site (Photo taken by Benjamin Whiting).

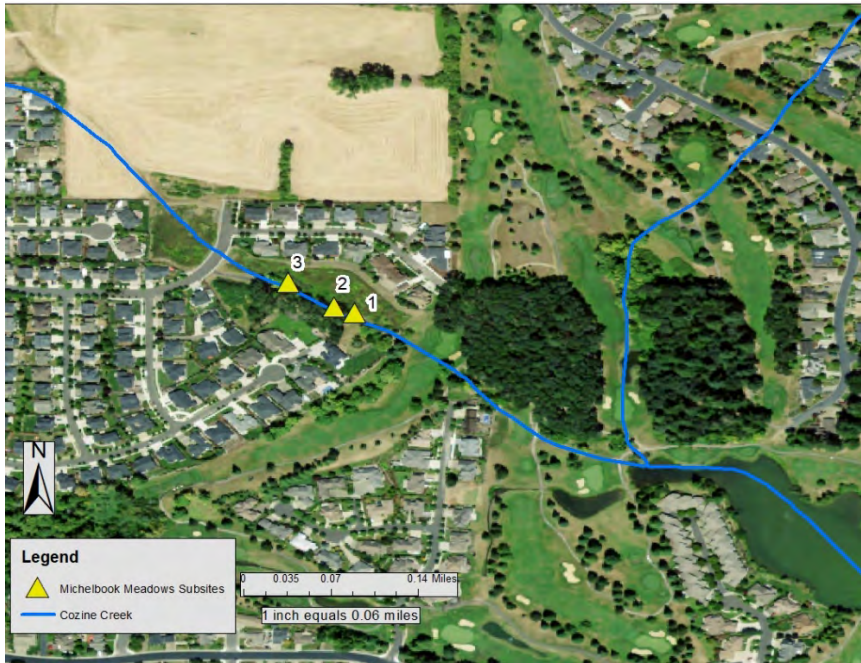
The third location where we tested water quality was where the North Fork of Cozine Creek flows through the Michelbook Meadows subdivision. This location was the furthest upstream of our sites and was located just above the Michelbook Country Club. It was chosen this year to test water quality above and below the golf course. Our class randomly selected three subsites to become our sampling locations (Figure 9). The site was very different from our other locations in that it was mostly wetland rather than a distinct creek. It also was surrounded by homes that lay just outside of the wetland area.

Figure 9. Map detailing location of the three Michelbook Meadow subsites on the North Fork of Cozine Creek (Map created by William McCuen using ArcGIS software).

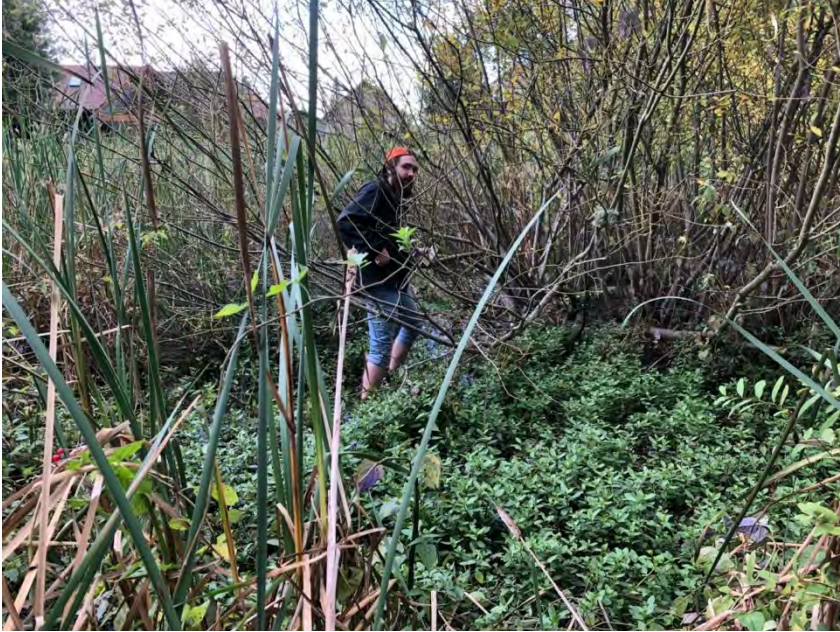
The width of the wetland area here was approximately 30 meters; the actual creek channel was not visible. This was the most downstream location at this site. Both sides of the wetland area were lined by nearby homes (Figure 10). The area was relatively flat with little to no bank sloping from the surrounding houses to the water. The area was very muddy with little to no flow. Slightly uphill of the wetland area were many Oregon white oak, Oregon ash, and willow trees. The vegetation in the marsh area included broadleaf cattails (*Typha latifolia*), bittersweet nightshade, duck weed (*Lemna minor*) and reed canary grass. Many red-winged blackbirds and a few killdeer were using the site while we were there. We also noted an abundance of spiders.

Figure 10. Michelbook Meadows Subdivision subsite 1 showing vegetation and the collection of water samples by Benjamin Whiting (Photo taken by Nancy Broshot).

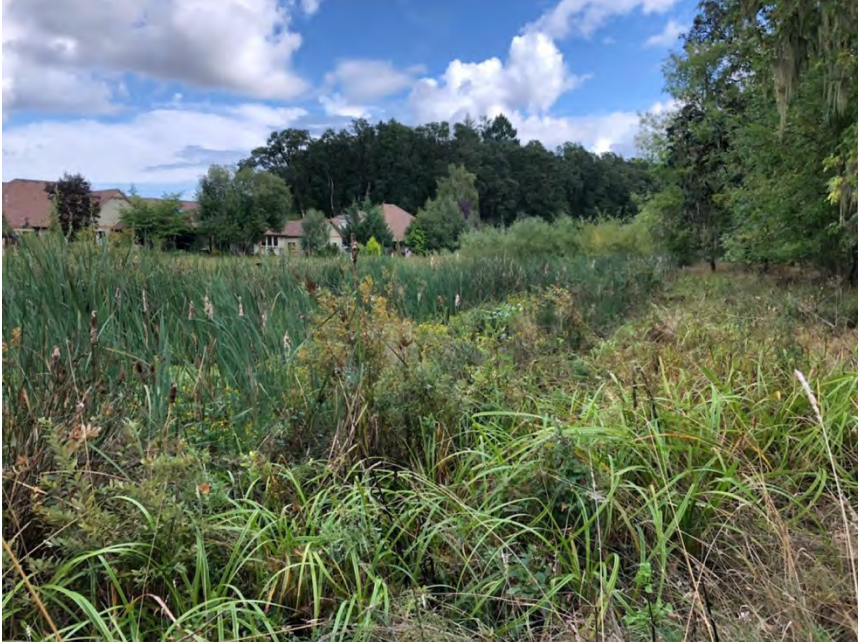
The area at subsite 2 was approximately 30 meters wide in a marshy area with a very muddy bottom. This site also was very flat with a very gradual slope from the surrounding homes to the water. The water at this subsite was extremely shallow; this site was the hardest for us to sample due to deep mud and an abundance of duckweed. The shore had Oregon ash, Oregon white oak, and willow trees that were covered in lichen (*Ramalina subleptocarpa*). The plants in the marsh included cattails, duckweed, reed canary grass, rushes (*Juncus sp.*), sedges (*Carex sp.*), and sword ferns (*Polystichum munitum*) (Figure 11). The red-winged blackbirds were also numerous here.

Figure 11. Michelbook Meadows Subdivision subsite 2 showing the marsh, nearby homes, and vegetation (Photo taken by Nancy Broshot).

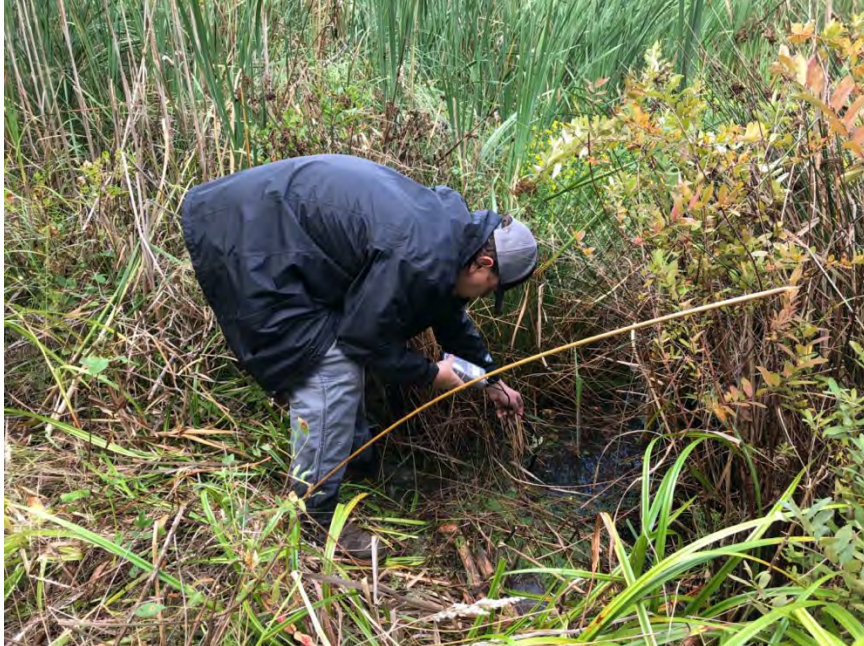
At this subsite, the marsh was approximately 20 meters wide and there were areas of open water. The location, while still flat, had slightly steeper muddy slopes to the water's edge. Oregon ash and willow were on the bank; cattails, sedges, duckweed, and reed canary grass were in the water (Figure 12). Other creek vegetation included spirea (*Spiraea douglasii*), sedges, Canada thistle (*Cirsium arvense*), snowberry, and rushes. We observed small fish (appeared to be reidside shiners) in the open water. The red-winged blackbirds occupied this area as well.

Figure 12. Photo of Garrett Scales measuring dissolved oxygen at subsite 3 at the Michelbook Meadows Subdivision. Photo shows shoreline and marsh vegetation (Photo taken by Nancy Broshot).

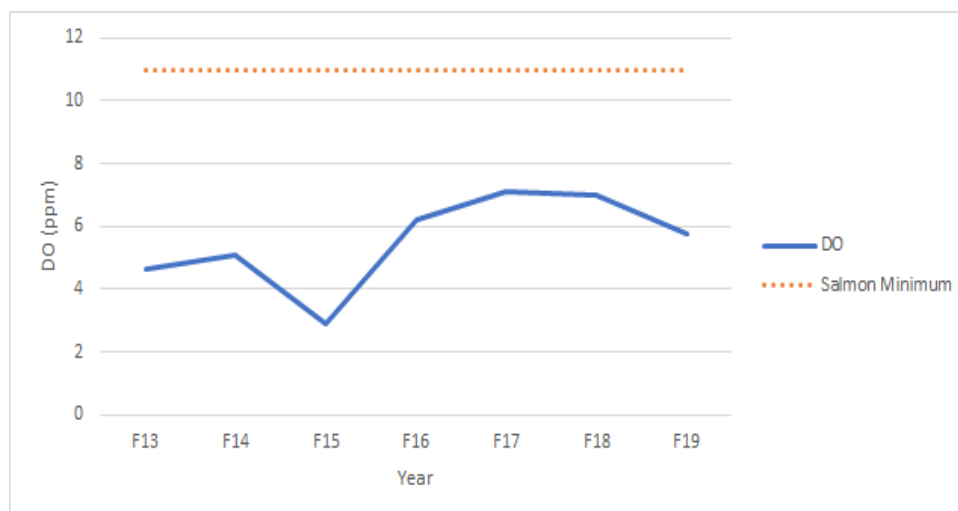
Figure 13. Mean dissolved oxygen (ppm) at the Linfield College site in fall 2013 to 2019. The dotted line represents the acceptable minimum DO (ppm) level for salmon at 11 ppm (Kidd, 2011).

Looking at dissolved oxygen in more detail, we can see it was significantly lower in 2013 to 2015 than it was in 2016 to 2019 (Figure 13). Even though oxygen levels have risen since fall 2015, they are still below the acceptable minimum level for salmon, which is 11 ppm. Levels below 6 ppm, which we found this fall, are lethal to salmon (Kidd, 2011). Besides salmon, DO is an important factor in all aquatic ecosystems because it affects the composition of freshwater communities (Connolly et. al., 2004). One reason Cozine Creek likely has such low levels of DO is that the flow, a factor that correlated positively with DO, is also low (USGS, 2014). Another reason could be that temperature, a variable that has a negative correlation with DO, is high in the creek (Connolly et al., 2004).

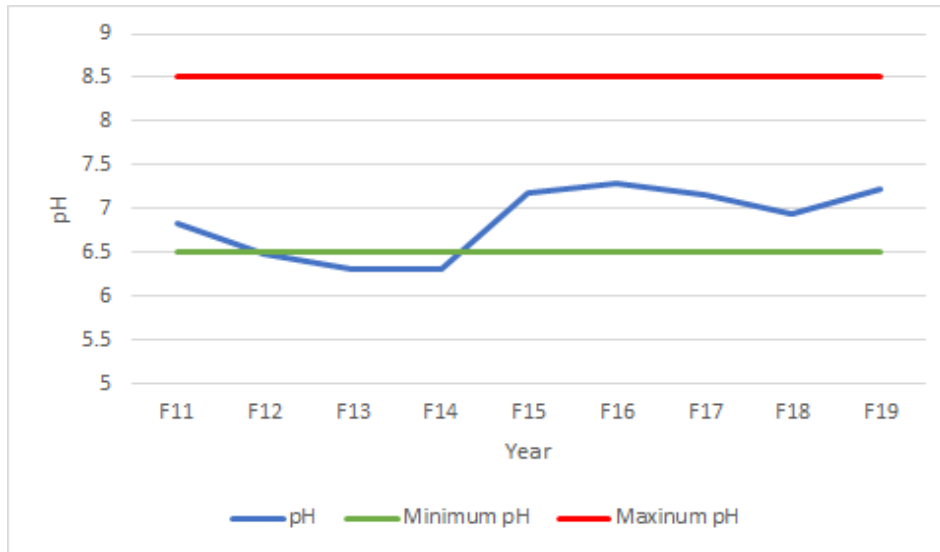
Figure 16. Mean pH at the Linfield College site in fall 2013 to 2019. The red line represents the DEQ acceptable maximum level for salmon at a pH of 8.5, whereas the green line represents the minimum level for salmon health at a pH of 6.5 (Fondriest Environmental, 2013).

pH was significantly higher in 2015 to 2019 than in 2012 to 2014 (Figure 16). The acceptable range for salmon is between 6.5 and 8.5 (Fondriest Environmental, 2013). Since 2015, the pH in Cozine Creek has been in the acceptable range. The pH of water can create a toxic environment for aquatic organisms by becoming too acidic or basic to support biological processes. pH also dictates the biological availability and solubility of chemicals in the water, including nutrients and heavy metals (USGS, 2016b). A pH too acidic or basic will burn a fish's skin and could cause damage to their gills and internal organs, making fish vanish from the waterway. A change in pH can be caused by any number of reasons including runoff, carbon dioxide sequestration, as well as an increase in temperature (Fondriest Environmental, 2013).

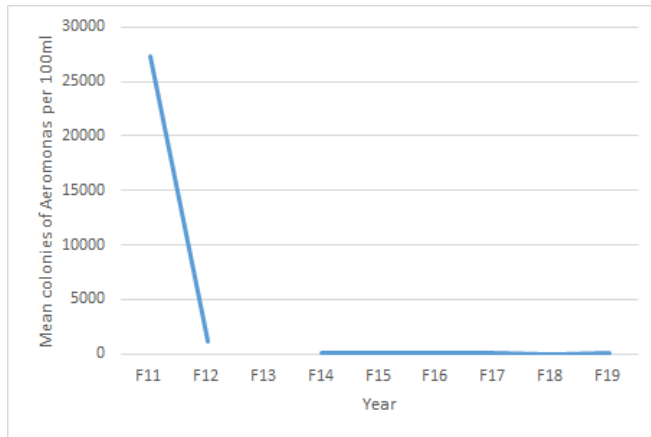
Figure 24. Mean levels of *Aeromonas* (colonies per 100ml) at the Linfield College site in the fall from 2013 to 2019.

Coliform bacterial levels in Cozine Creek have decreased since 2011. *E. coli* level have been significantly lower since 2011 (Figure 22). *Salmonella* were significantly higher in 2011 than 2013, which was higher than all other years (Figure 23). *Aeromonas* levels were significantly in 2011 than 2012, which was higher than levels in 2015 to 2019 (Figure 24). The high levels in 2011 were due to a broken sewer pipe upstream. The repair of that has led to much lower levels since. Lower levels mean that there are less potentially harmful bacteria in the waterway. It also means that the fecal waste from warm-blooded vertebrates has been reduced. (CDC, 2015). The decrease in coliform levels should be beneficial for DO as bacteria consume DO (Connolly et al., 2004), however DO levels in the creek have continued to remain low suggesting bacteria are not the cause of the low oxygen in Cozine Creek.
