Examining Water Quality and Vegetation Along Cozine Creek
Senior Capstone ENVS 460: Fall 2020

Megan Angier, Travis Delima, Hannah Hopkins, Lily Hulsman, Jordan Leis, McKenna Musser,
Jake Prodzinski, Colton Ramos, and Jiarong Wan

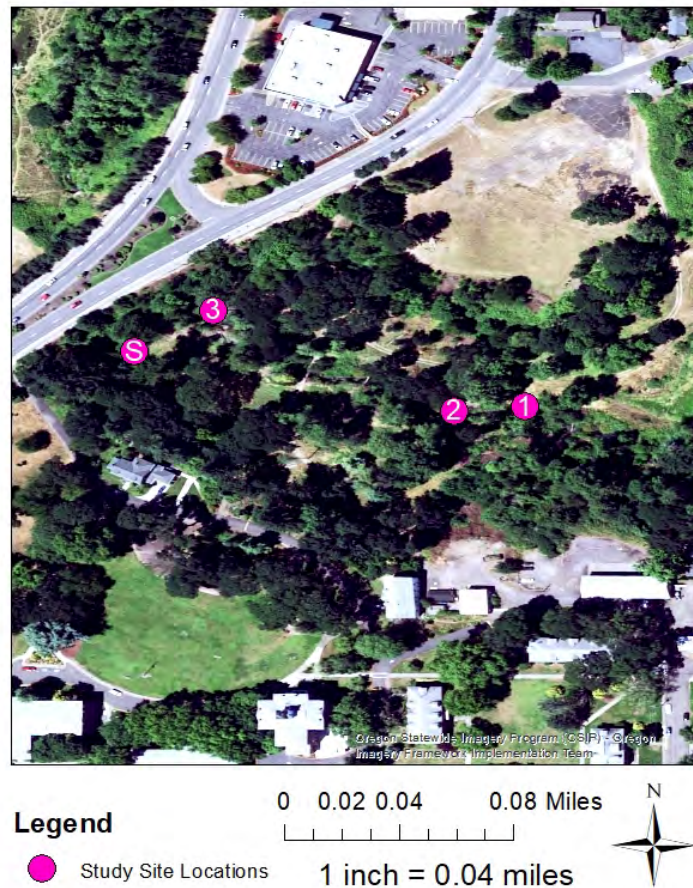
Figure 3. Linfield University (Campus) showing subsite locations. Each subsite is marked in the dot location on the map with the number noting the subsite name; S is the side stream. Map made using ArcGIS by Lily Hulsman.

The site at Linfield University (called “Campus” in this study) was located along Cozine Creek as it flows through the north end of the campus (Figure 3). The Campus site has been tested annually by senior ENVS students since Spring 2011. There were three subsites along Cozine Creek (selected in 2011) with a fourth site (the sidestream) that was added in 2017 (Figure 3).

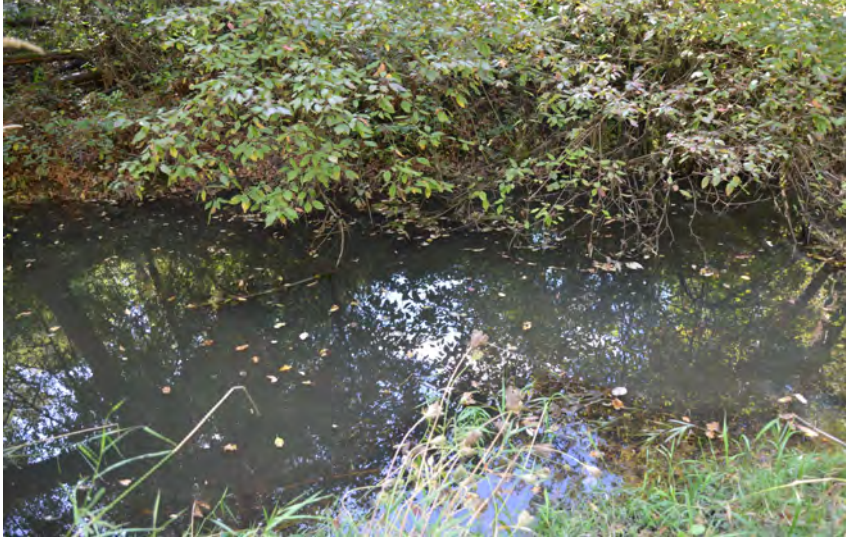
Figure 4. Photo taken at the Campus subsite #1 by Jordan Leis on 09/23/20.

The creek at subsite 1 was approximately 10 feet wide with no flow due to downed woody debris downstream. The lack of flow allowed large quantities of duckweed to cover most of the surface of the water. The bottom of the creek was predominantly mud. This subsite was the most downstream of the sampling areas for this site (Figure 3). The vegetation at this subsite included many Oregon ash trees that shaded the creek. Shrubs found at the subsite included creek dogwood and ninebark (*Physocarpus capitatus*) (Figure 4). Herbaceous plants included trailing blackberry, reed canary grass, and lemon balm (*Melissa officinalis*).

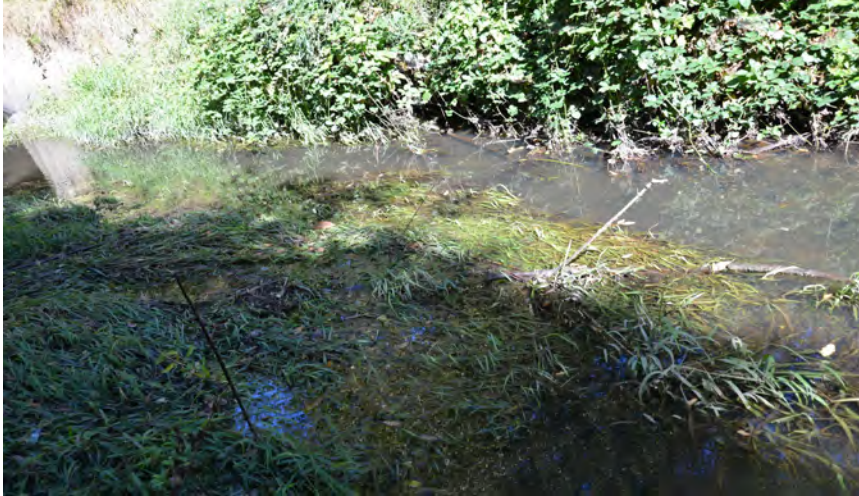
Figure 5. Photo taken at Campus subsite #3 by Jordan Leis on 09/23/20.

This subsite was the most upstream of the three main subsites (Figure 3) and was located as the creek flowed onto the campus below the culvert that runs under Baker Street. The culvert separated the stream into two separate rectangular tunnels that rejoined into a narrow stream as they entered campus. This section of the creek was only two feet wide and had a higher flow, less shade, and a mud substrate. Trees present included black cottonwood, Oregon ash, and red alder. The shrubs consisted of Himalayan blackberry and Douglas' spiraea (*Spiraea douglasii*). A large amount of reed canary grass covered much of the south side of the bank (Figure 5).

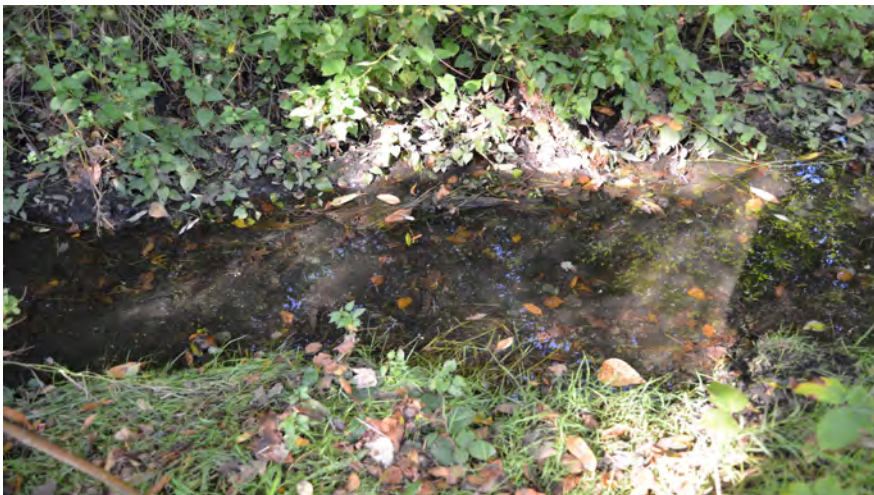
Figure 6. Photo taken at the Cozine Creek University Side-stream Subsite by Jordan Leis on 09/23/20.

This site is on a small side stream that empties into Cozine Creek at subsite 3 (Figure 3). The stream appears on the hill between Baker Street and the President's house. This site was added in 2017 to determine how it impacted the Campus site's water. It still is unclear what the source of the water is. The stream was about 2 feet wide. Trees included vine maple (*Acer circinatum*) and Oregon ash, as well as an ornamental birch tree (*Betula sp.*). The understory included sword fern (*Polystichum munitum*), bittersweet nightshade (*Solanum dulcamara*), snowberry (*Symphoricarpos albus*), trailing blackberry, and invasive Italian arum (Figure 6). The sidestream substrate was mostly mud with some rocks scattered along the stream bank.

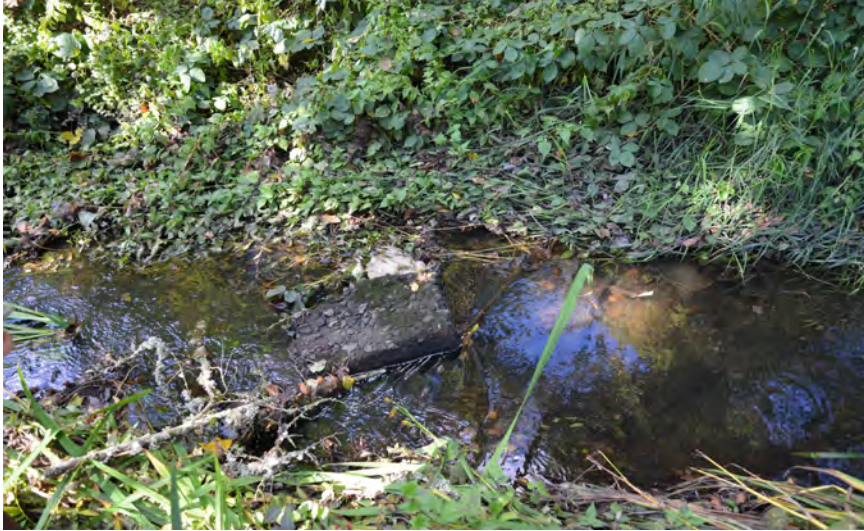
Figure 8. Photo taken of the Library Subsite 1 by Jordan Leis on 09/30/20.

The creek at this site was approximately 5 feet wide and was the most downstream sampling area at this site (Figure 7). The substrate was mud with scattered pebbles and chunks of concrete. Overstory trees included Oregon ash, a non-native poplar (*Populus sp*), a willow, and Douglas-fir. The understory consisted of many invasive species including yellow flag iris (*Iris pseudacorus*), lemon balm, bittersweet nightshade, creeping buttercup (*Ranunculus repens*), and Himalayan blackberry. Native species included trailing blackberry (Figure 8).

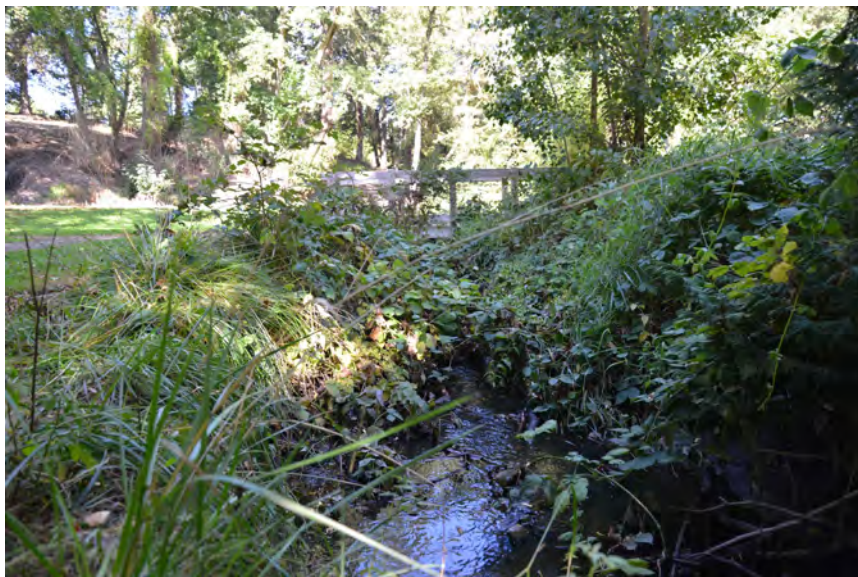
Figure 9. Photo of Library subsite #2 taken by Jordan Leis on 09/30/20.

The second subsite was upstream from the first and approximately 4 feet wide (Figure 7). The stream ran beneath a foot bridge immediately upstream from this site (Figure 9). There were several non-native popular trees in the area that shaded the creek, along with Himalayan blackberry. Other tree species included non-native English hawthorne (*Crataegus monogyna*) and Port Orford cedar (*Chamaecyparis lawsoniana*). Groundcover included wild blackberry, reed canary grass, and rush.

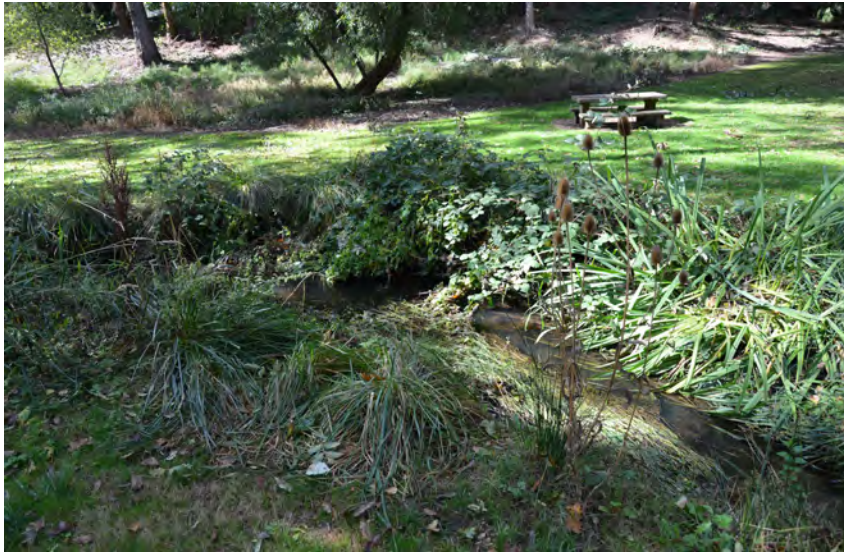
Figure 10. Photo of Library Subsite 3 taken by Jordan Leis on 09/30/20.

The third subsite was approximately 8 feet across and was the most upstream sampling location (Figure 7). The creek substrate was a mixture of mud and silt with large rocks and concrete slabs scattered in the muck. The flow appeared to be faster at this subsite. Trees in the area were all ornamental species of poplar and alder. Groundcover included yellow flag iris, bittersweet nightshade, and Himalayan blackberry (Figure 10). We also found *Ludwegia sp.*, a particularly bad aquatic species at this site.

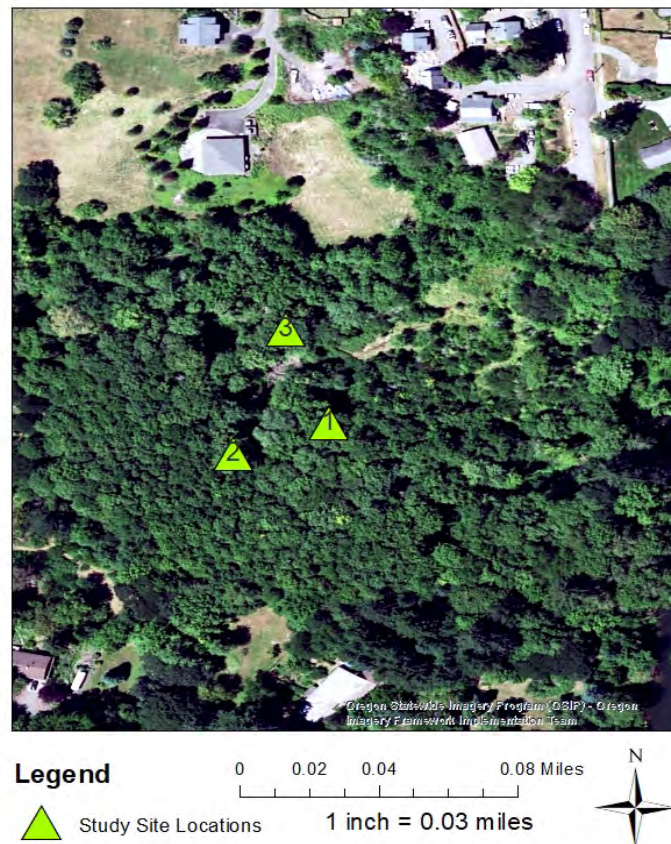
Figure 11. Shady Street Site showing subsite locations. Each subsite is marked in the dot location on the map with the number noting the subsite name. Map made using ArcGIS by Lily Hulsman.

The Shady Street site was located in the area just above where Cozine Creek empties into the South Yamhill River (Figure 11). The area was surrounded by a riparian forest of native Oregon ash trees. This site had three subsites (Figure 11). The creek here was more deeply incised than at the other two sites, resulting in steep banks. The substrate was very muddy. This area has historically attracted transient populations that leave behind trash and debris.

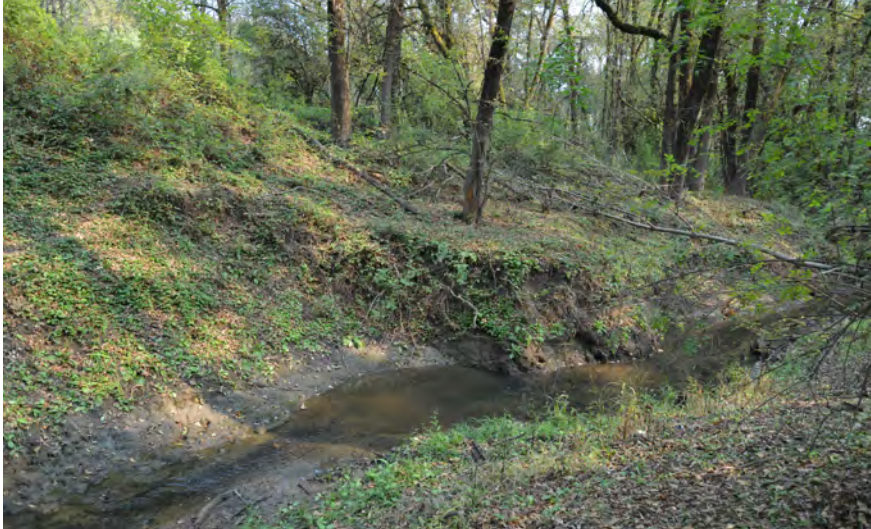
Figure 12. Photos of Shady Street Subsite 1 taken by Jordan Leis on 10/07/20.

The first subsite was located down a steep slope and was the most downstream of the three sampling locations here (Figure 11). The creek was about 4 feet wide and there was woody debris in the creek upstream of our sampling area that reduced the flow of the stream. Many Oregon ash trees were located in the riparian forest above the creek that shaded the water. The understory vegetation included Himalayan blackberry, English hawthorn, wild rose (*Rosa multiflora*), and ninebark (Figure 12). The creek bed was very muddy with areas with small pebbles.

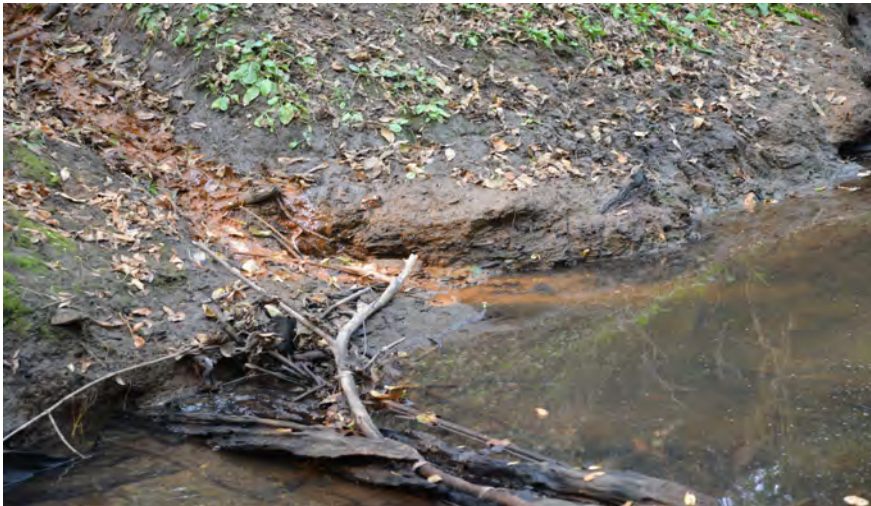
Figure 13. Photo of Shady Street Subsite 2 showing the side stream taken by Jordan Leis on 10/07/20.

Subsite 2 was located upstream from subsite 1 (Figure 11). A small rivulet with incised banks and a copper colored bottom flowed into Cozine Creek here (Figure 13). The creek was about 4 feet wide and had a very muddy bottom. The area above the creek had Oregon ash trees that shaded the bank. The bank itself was covered with Himalayan blackberry, reed canary grass, snowberry, evergreen blackberry (*Rubus laciniatus*), and unidentified herbs. Trash was found at this site.

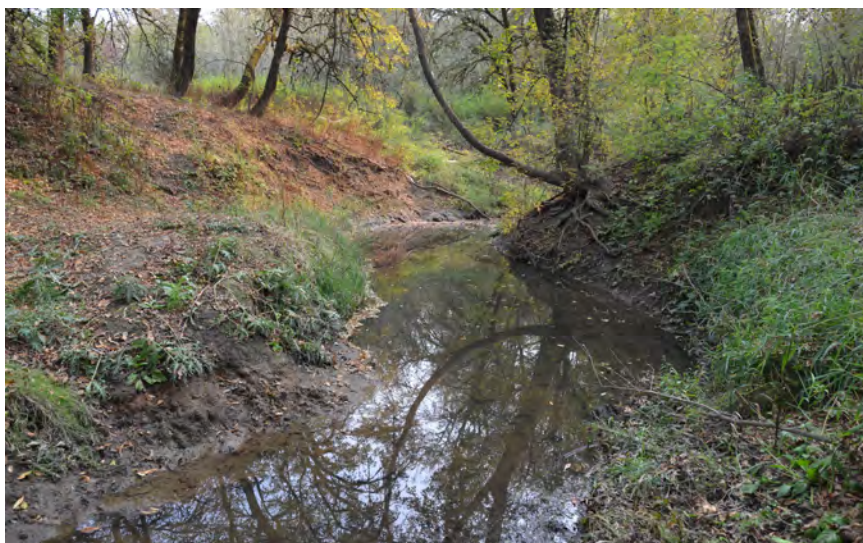
Figure 14. Photo of Shady Street Subsite 3 taken by Jordan Leis on 10/07/20.

This subsite was the most upstream site sampled at this location (Figure 11). It was located upstream of a large debris dam that resulted in very low flow. The creek was approximately 10 feet wide with a muddy substrate. Trees found above the creek included Oregon ash and English hawthorne. The understory included Himalayan blackberry, creek dogwood, snowberry, and wild rose (*Rosa multiflora*) (Figure 14).

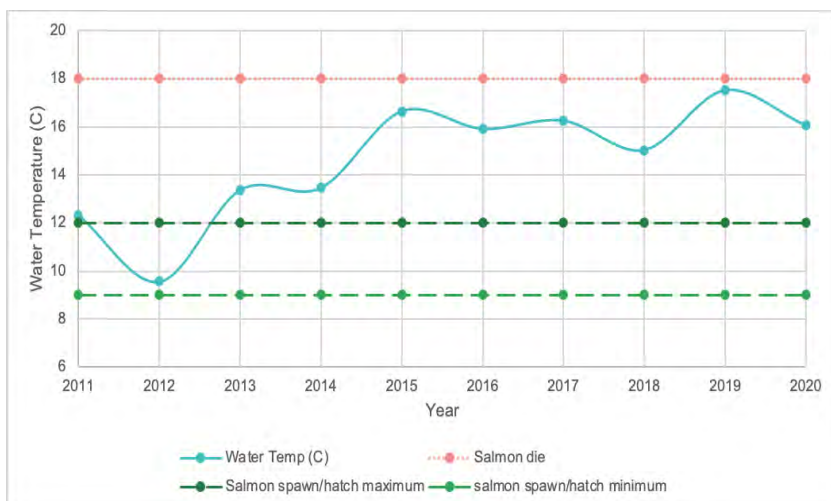
Figure 15: Mean temperature (°C) at the Linfield Campus site fall 2013 to 2019. The dotted line represents the maximum temperature for salmon to live, 18°C (EPA 2003).

When we examine the water quality on the Campus site where we have been sampling the water for ten years, we see some interesting trends. Water temperature at the Campus site has been above levels where salmon can spawn and hatch for the entire time, we have been sampling (Figure 15). Temperature was significantly lower in 2012 than the other years, but still not within the limits required for salmon. Temperatures below 9°C are required for salmon to spawn, and they die above 18°C (EPA 2003).

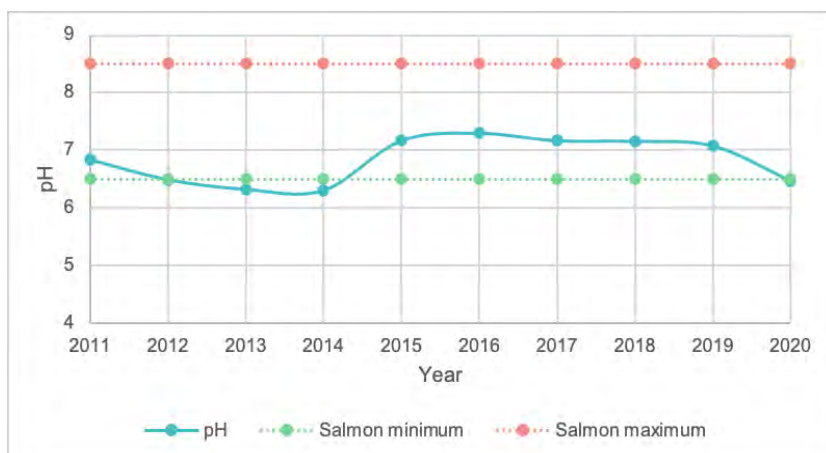
Figure 17. Mean pH value of Linfield Campus site fall 2011 to 2020. Dotted lines represented maximum and minimum values where salmon and trout can live (Sauter et al. 2001).

pH at the Campus site has fluctuated (figure 17). The level between 2015 and 2019 was in the acceptable range for salmon but dropped close to the level unfit for them this year (Sauter et al. 2001).

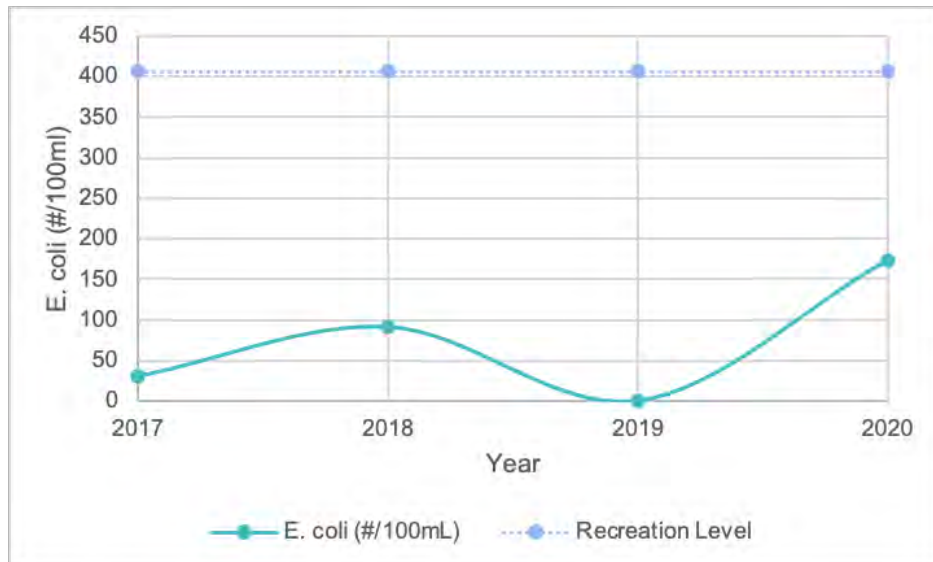
Figure 21. Mean *E. coli* colonies at the Library site fall 2017 to fall 2020. The maximum amount allowed for human recreational use is represented by the dotted line (DEQ 2020).

Levels of *E. coli* have also fluctuated (Figure 21) but at their highest in 2020. In all years, the level has been below the recreational limit for human use in streams. The level found this year could be from an increase amount of people taking their dogs to the public park and not cleaning up or to the geese that live upstream at the Michelbook Golf Course.

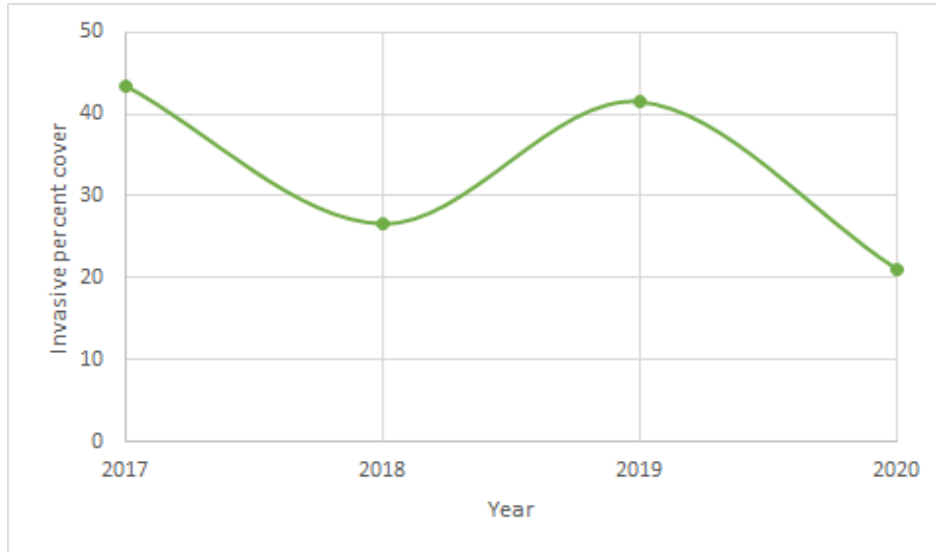
Figure 22. Mean percent total invasive species cover on Newby hill from 2017 to 2020.

Vegetation is important for streams; native plants provide shade, which helps keep the water cool, prevents erosion, and filters pollutants, preventing them from entering waterways. The Cozine restoration project has focused on removing invasive vegetation and replacing it with native trees, shrubs, and ground cover. Students first started measuring vegetation on Newby Hill in 2017, a year after hand removal began. This year we found percent cover by invasive species on Newby Hill had significantly decreased from 2017 to 2020 (Figure 22). This suggests the restoration work of hand removal in this area of campus is having a positive impact on native plant restoration by decreasing the number of invasive species that out-compete and reduce native biodiversity (OSU 2020). Though the overall percentage is decreasing we did find small increases in abundance of invasive species like Italian arum and reed canary grass, which are harder species to control. We also found that the planting of native species is helping, and the snowberry, which was planted on Newby hill in 2018 and 2019, has increased in number and appears to be reproducing on its own.
